Manhole Inspection Summary

Manhole # S25EE_011MH

Insp Date: **10/11/07 9:10 AM**

Location Address: **1143 FREEMONT AVE**

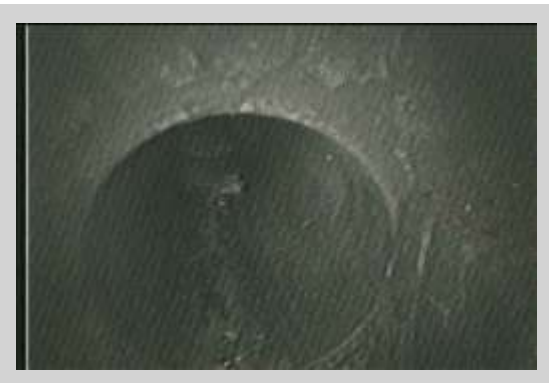
8 in. Circular Gravity Sewer Pipe In @ 6 O'Clock

Rod and Bar (Angled)

Pipe Material: **Clay** ☐ Pipe Lined

Infiltration: **None** Pipe Seal Cond: **Unknown**
